Report Number: 214-TRC-03-016

Safety Compliance Testing For FMVSS 214

Side Impact Protection

2004 Suzuki Forenza S 4-door

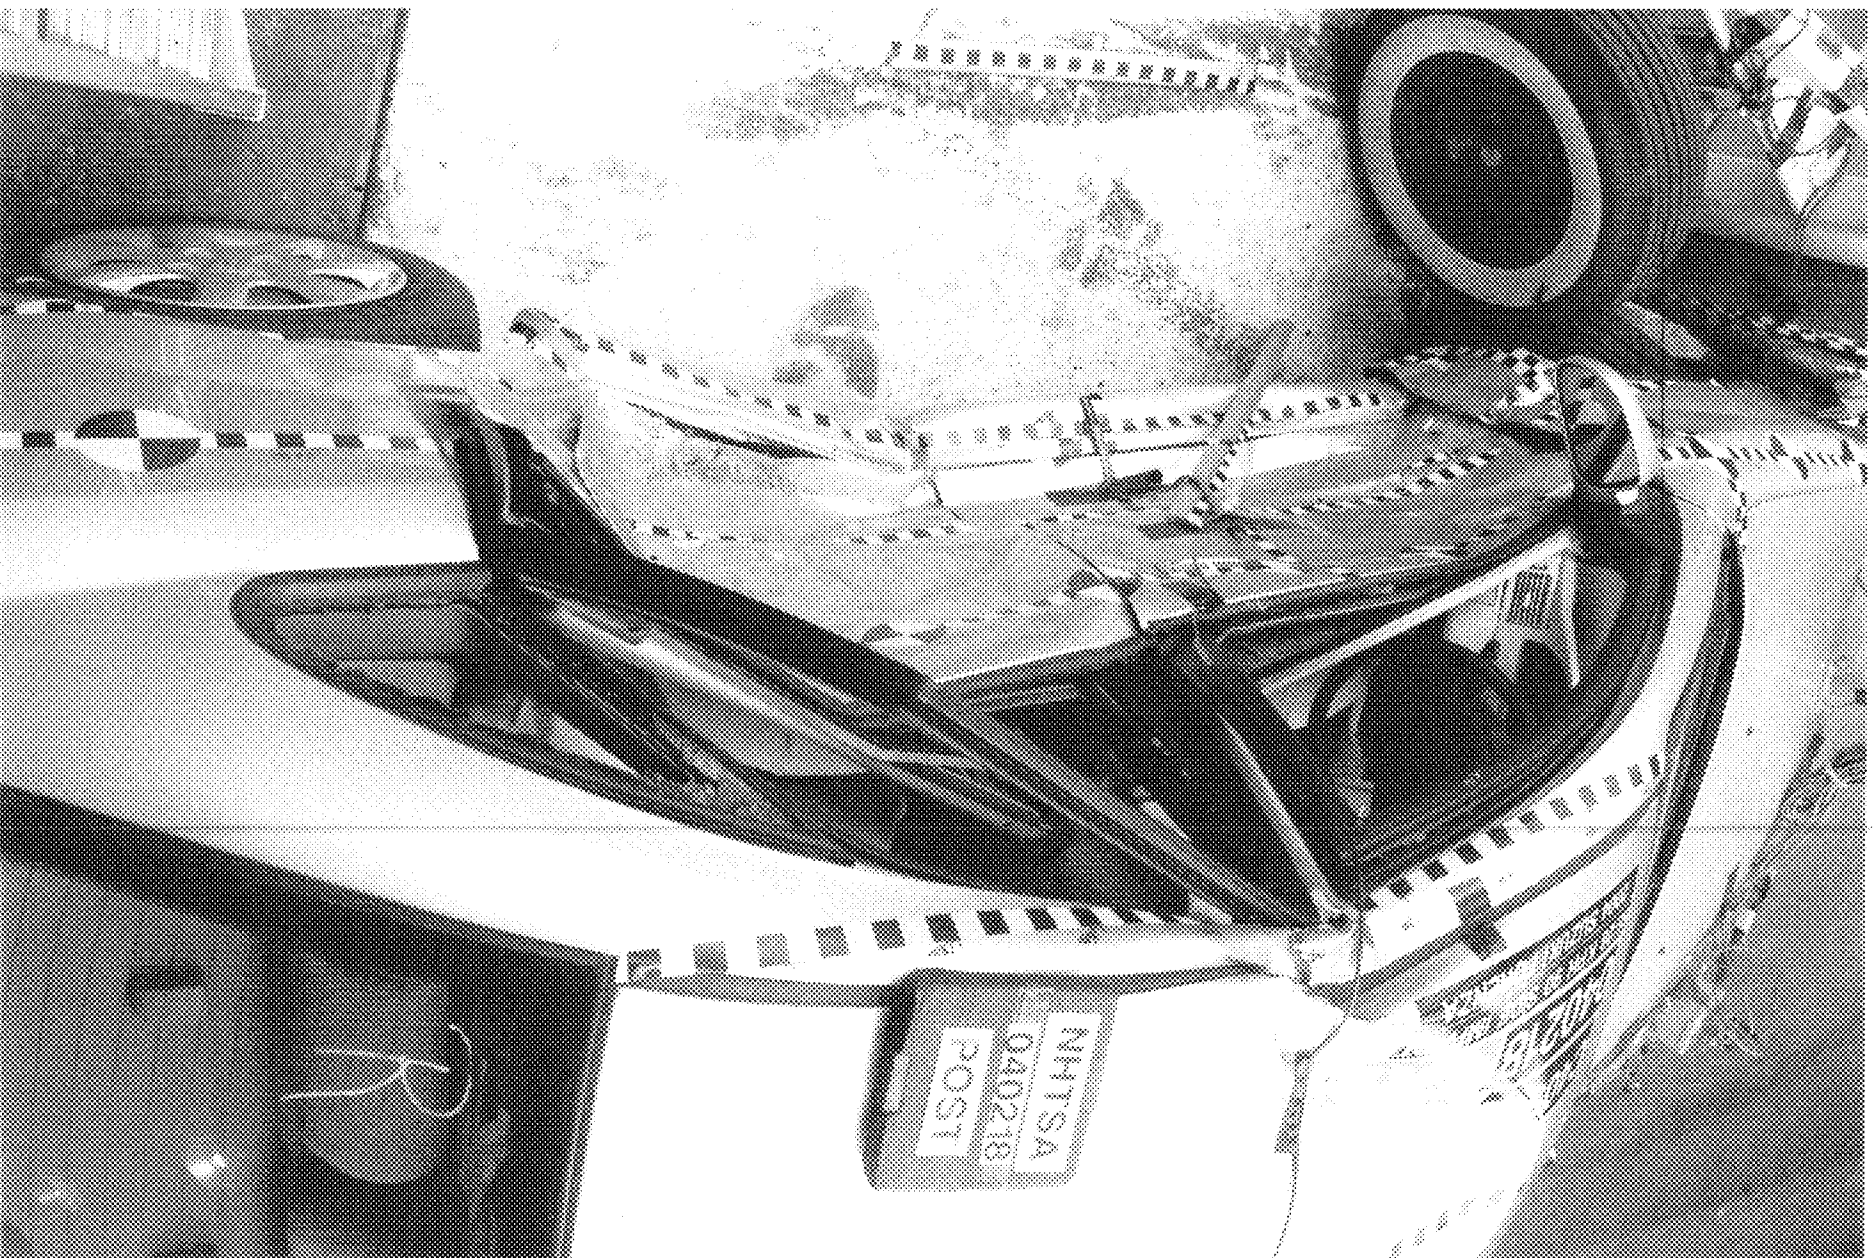
Figure A-17 Post-Test Overhead View of Vehicle

Full length of induced damage was 2250 mm.

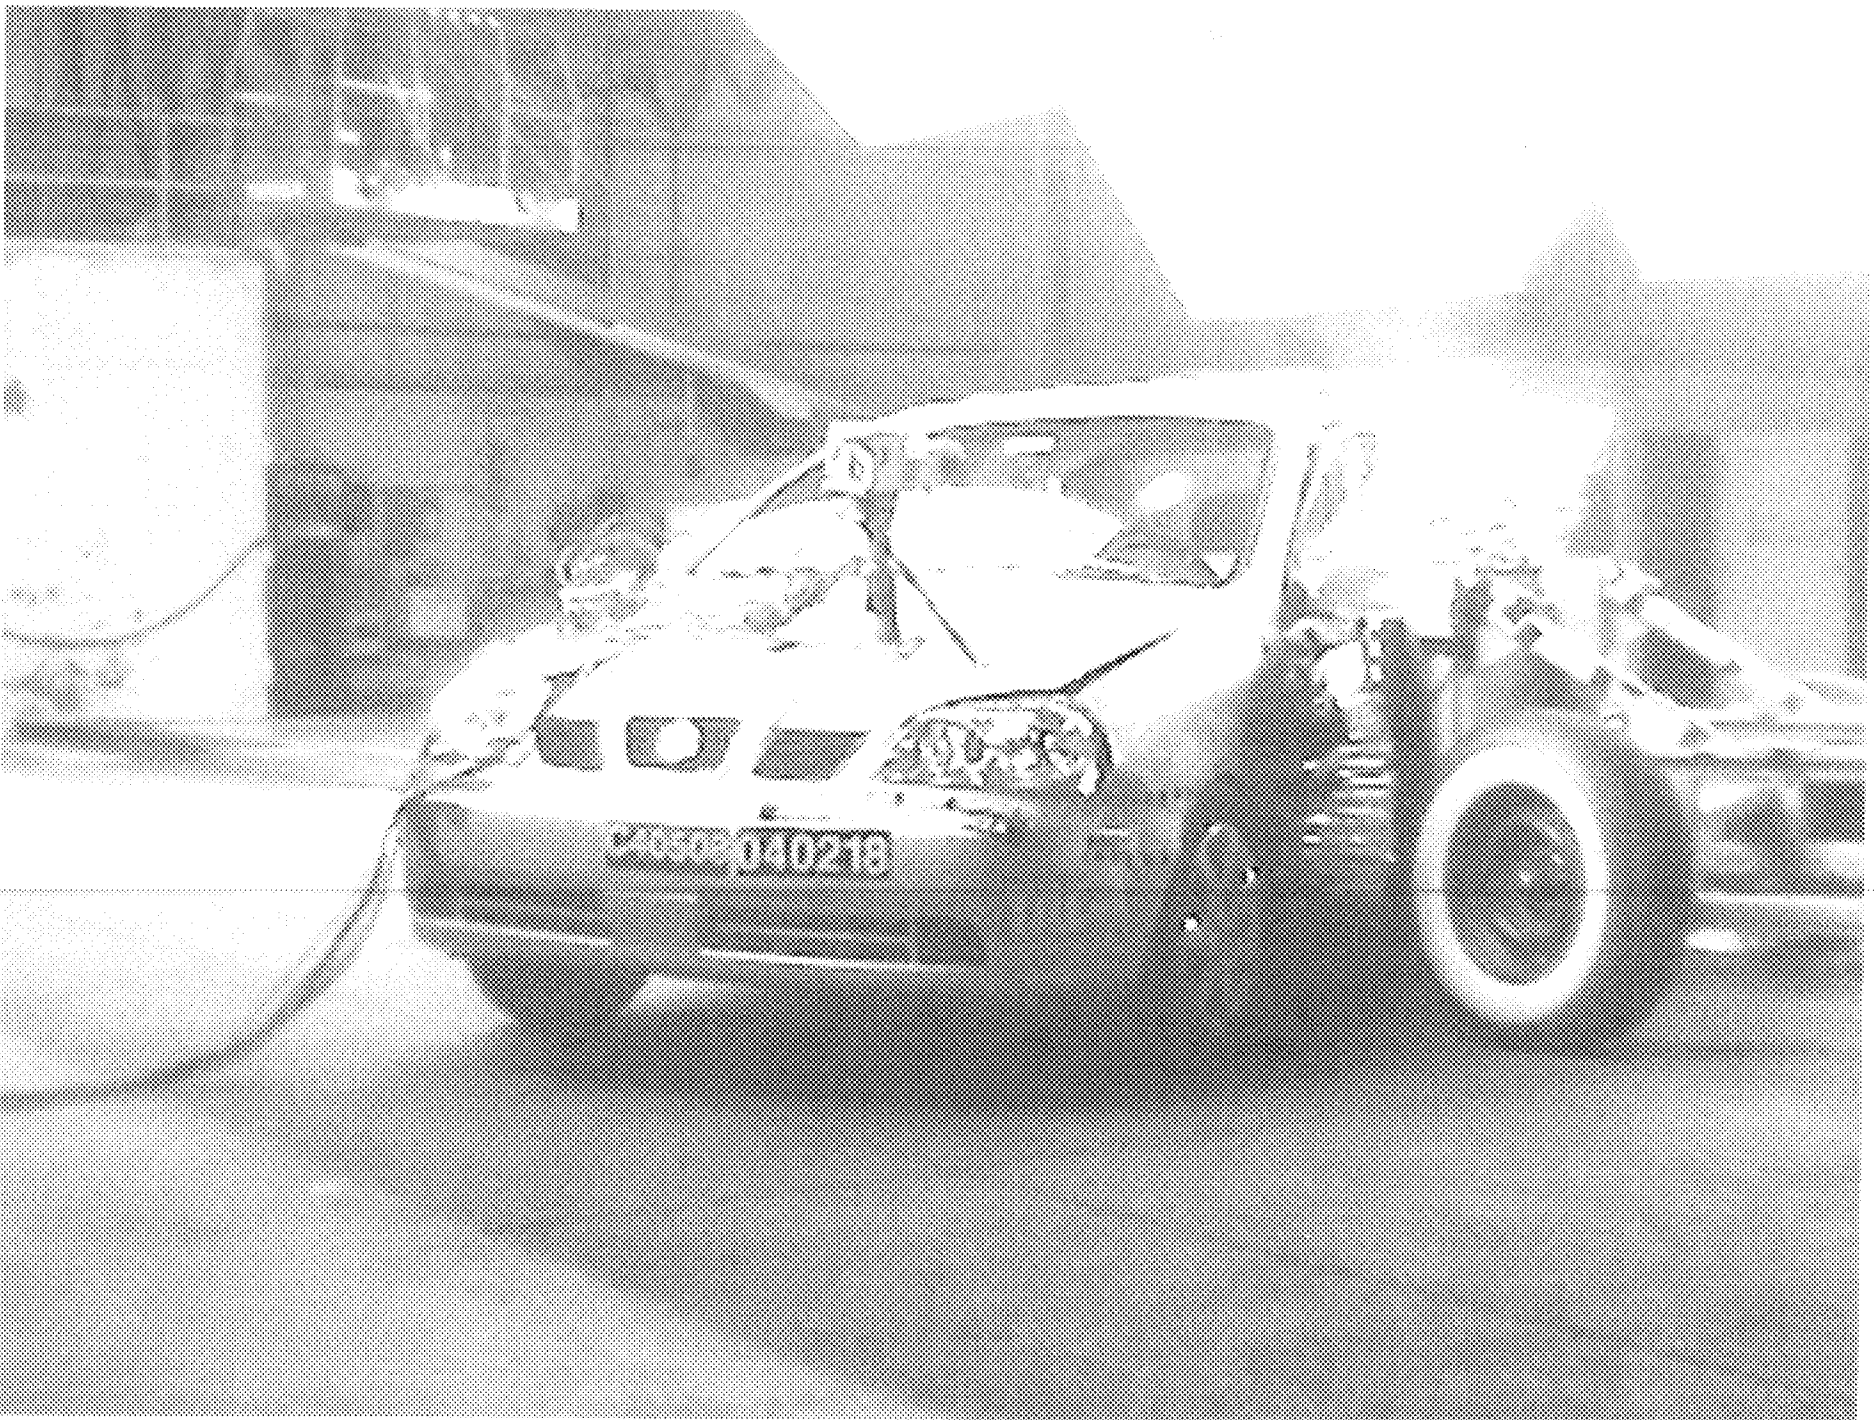
Figure A-46 Impact Event
A-49

A 2004 Suzuki Forenza S 4-door was impacted on the driver's side by a Moving Deformable Barrier (MDB) which was moving forward in a 27° crabbed position to the monorail at a velocity of 62.0 km/h (38.5 mph). The target vehicle was stationary and was positioned at an angle of 63° to the line of forward motion. The side impact test was conducted by Transportation Research Center Inc. in East Liberty, Ohio on February 18, 2004. Pre-test and post-test photographs of the test vehicle, the moving deformable barrier (MDB), and the side impact dummies (SID HIIIs) are included in Appendix A.
